**BOEING AIRPLANE COMPANY**  
**WICHITA, KANSAS**

DOCUMENT NO. WD-14018 DATE January 31, 1956

MODEL BC-47E CONTRACT NO. 5148

TITLE ANALYSIS OF WFT-709 FLIGHT TESTS OF NAVIGATOR'S  
COMPARTMENT DEFROSTING SYSTEM

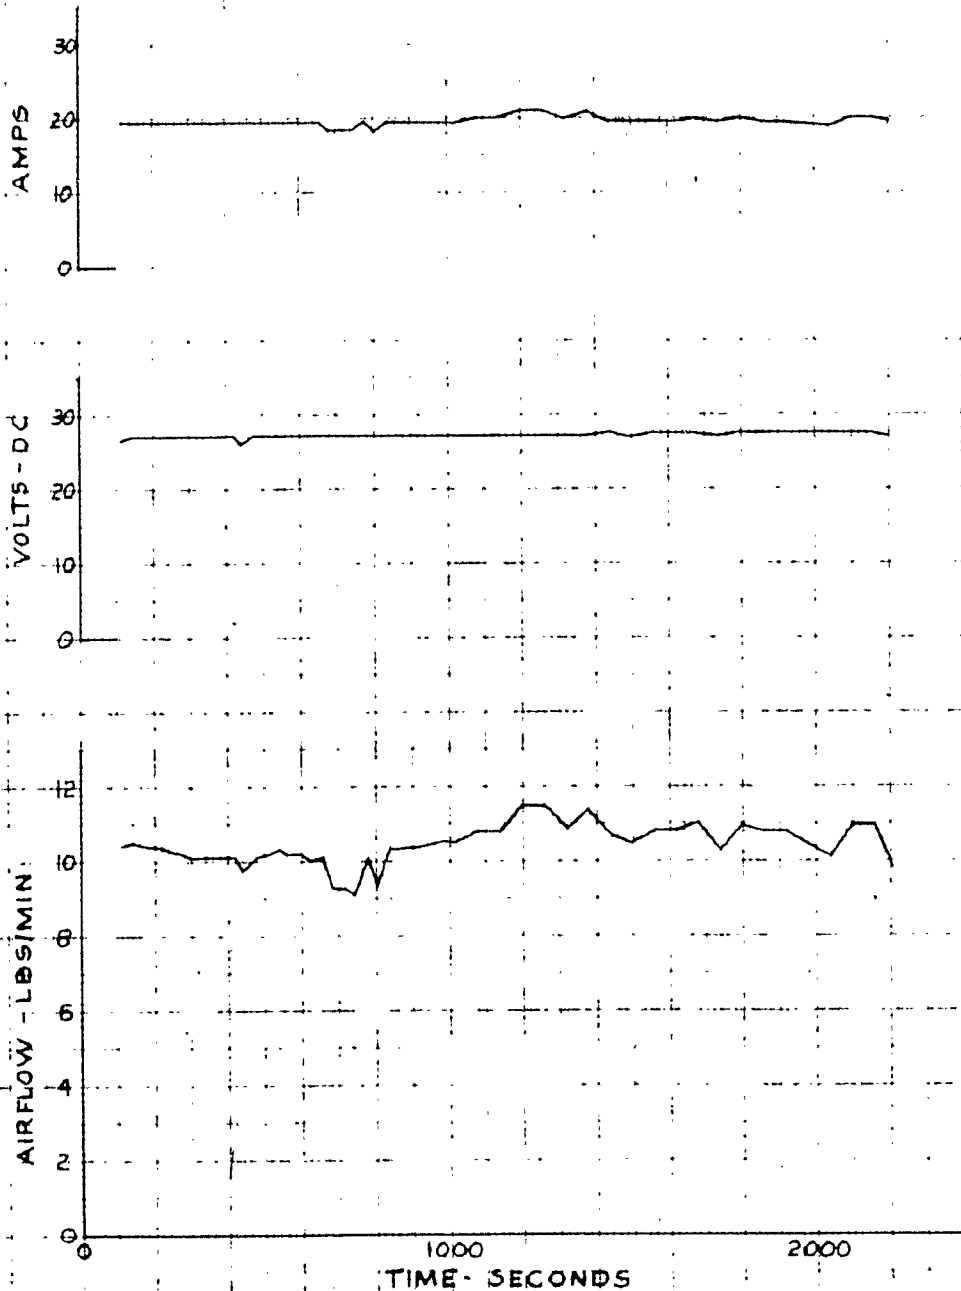
NOSE COMPARTMENT DEFROST BLOWER AIRFLOW  
WITH VOLTAGE AND AMPS DURING LOW ALTITUDE  
HIGH SPEED DASH TEST 9-1 C/N 8915 TO 11005  
C/N 8800 + 0 TIME  
BLOWER INLET STATIC PRESSURE (CABIN) APPROXIMATELY 2890 IN HG ABS  
AIRPLANE ALTITUDE APPROXIMATELY 1750 ± 250 FT.

CALC	<i>JBK</i>	10-22-55	REVISED	DATE	DEFROST BLOWER AIRFLOW DURING LOW LEVEL PHOTO RECONNAISSANCE TEST 9-1	FIGURE
CHECK						34
APR						RB-47E
APR						WD-14018
					BOEING AIRPLANE COMPANY WICHITA 1, KANSAS	PAGE 35 OF
CONTRACT NO.

The blower airflow at altitude for test 9-1 averaged about 9.5 lbs/min at 27 volts and 18.5 amps as noted in Figures 33 and 35. During the high altitude photo run of test 9-2 the airflow was approximately 11 lbs/min, as shown in Figure 36, but this could be explained by the fact that the voltage is 28 and the current is approximately 21 amps. Figures 34 and 37 show the airflow for the low altitude high speed dash during test 9-1 and 9-4. The blower operation is quite erratic for both tests but 9-4 shows the more pronounced fluctuation. The apparent erratic operation of the blower is believed to result from the fluctuating bleed airflow which is shown in Figures 28 and 32. The method of determining the blower airflow may also be a contributing factor to the apparent erratic airflow. Since the total system airflow was not measured, the blower airflow was estimated by means of relationship of blower output to input current. This also explains the reason for the similarity between the blower airflow and the current curves in Figures 34 and 37.

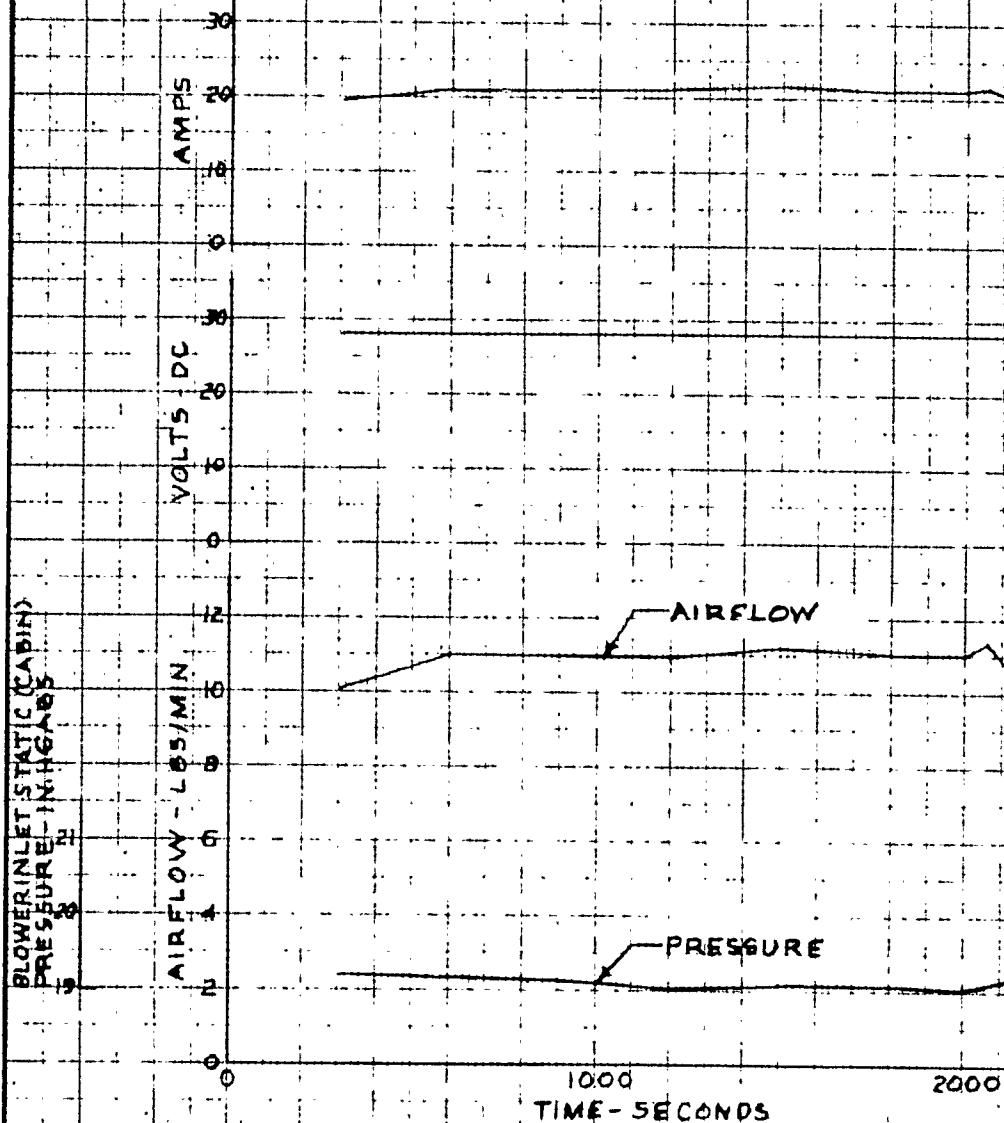
NOSE COMPARTMENT DEFROST BLOWER AIRFLOW  
WITH VOLTAGE AND AMPS DURING HIGH ALTITUDE  
PHOTO RUN TEST 9-2 Q/N 15309 TO 17120  
C/N 15000 = 0 TIME

DEFROST BLOWER AIRFLOW DURING HIGH  
ALTITUDE PHOTO RECONNAISSANCE - TEST 9-2

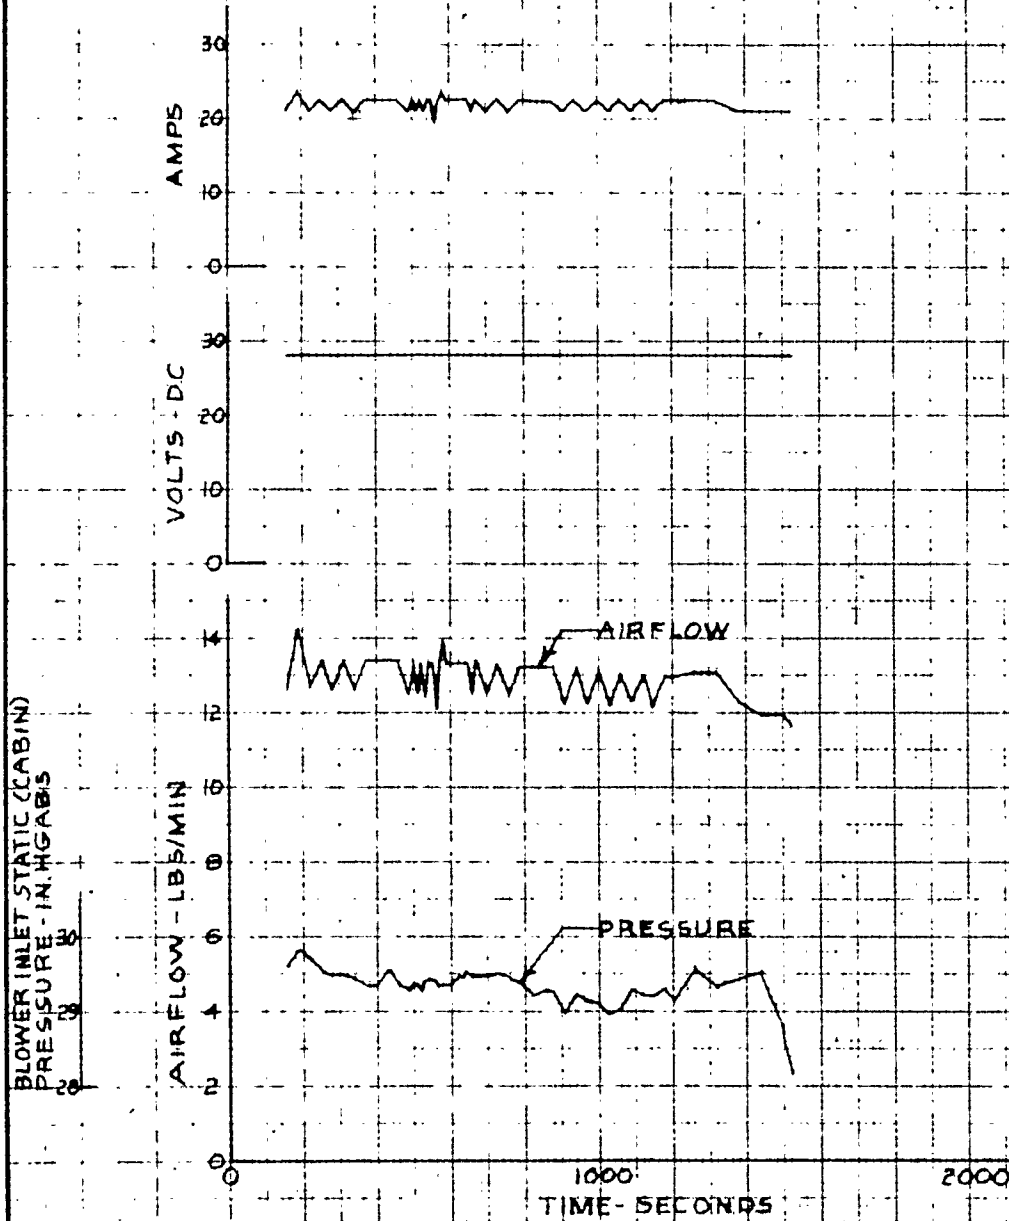
NOSE COMPARTMENT DEFROST BLOWER AIRFLOW  
WITH VOLTAGE AND AMPS DURING LOW ALTITUDE  
HIGH SPEED DASH TEST 9-4 C/N 9900 TO 11325  
C/N 9800 ± 0 TIME

DEFROST BLOWER AIRFLOW DURING LOW  
LEVEL PHOTO RECONNAISSANCE - TEST 9-4

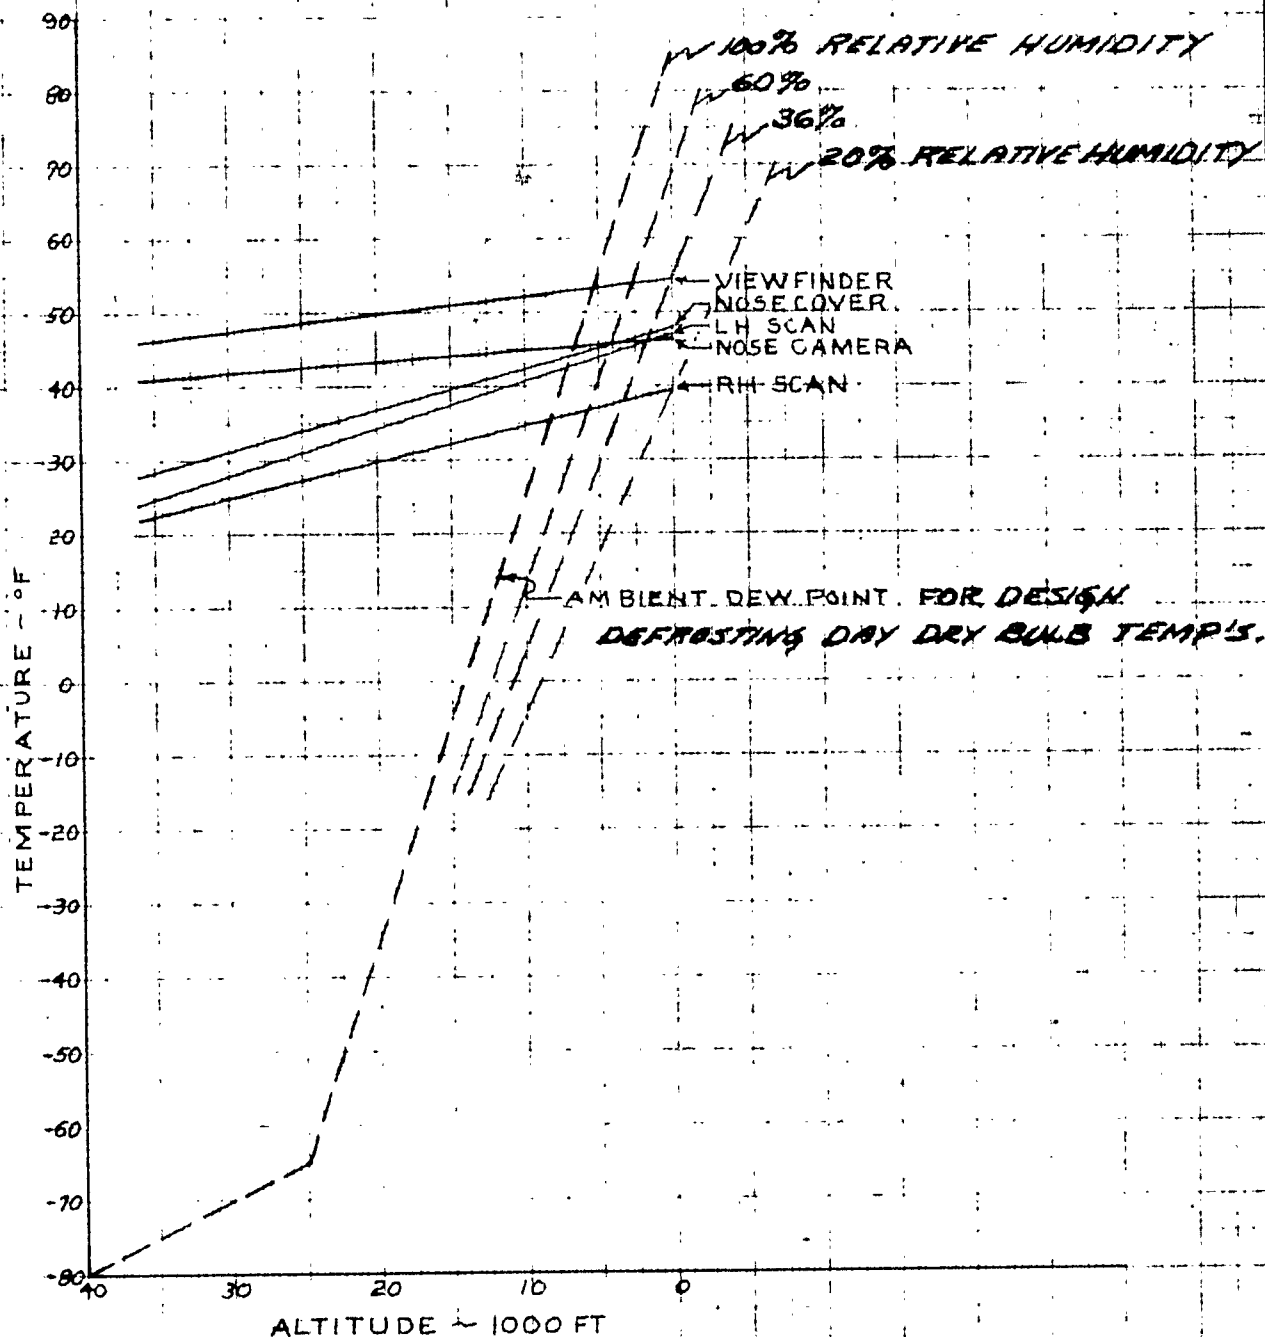
PREDICTED INSIDE WINDOW SURFACE TEMPERATURE  
RISE DURING A MAXIMUM RATE DESCENT FROM 36,000 FT  
ON A DESIGN DEFROSTING DAY  
(STEADY STATE CONDITIONS ASSUMED PRIOR TO DESCENT)  
(AVERAGE DESCENT RATE OF 60.50 FT/MIN)

PREDICTED INSIDE WINDOW SURFACE TEMPERATURE RISE DURING A MAXIMUM RATE DESCENT FROM 36,000 FEET

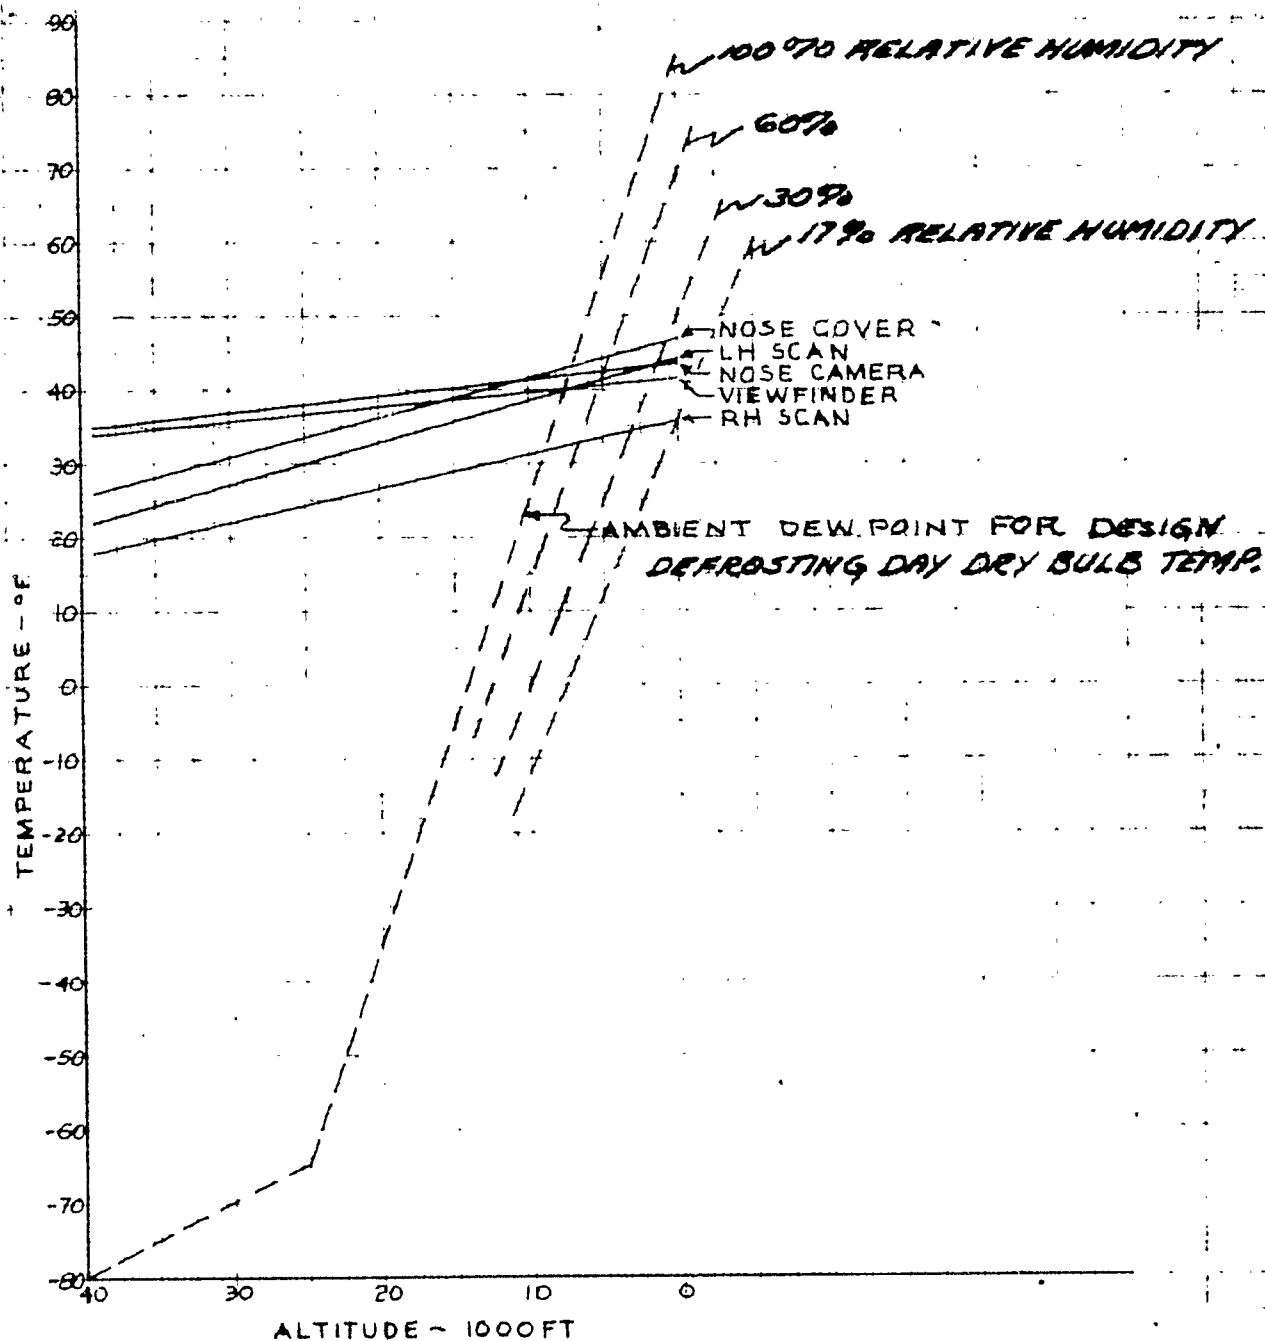
FIGURE  
40  
RB-47E  
WD-14018  
PAGE 1  
OF

PREDICTED INSIDE WINDOW SURFACE TEMPERATURE  
RISE DURING A MAXIMUM RATE DESCENT FROM 39000 FT  
ON A DESIGN DEFROSTING DAY  
(STEADY STATE CONDITIONS ASSUMED PRIOR TO DESCENT)  
(AVERAGE DESCENT RATE OF 6050 FT/MIN)

PREDICTED INSIDE WINDOW SURFACE TEMPERATURE RISE DURING A MAXIMUM RATE DESCENT FROM 39,000 FEET

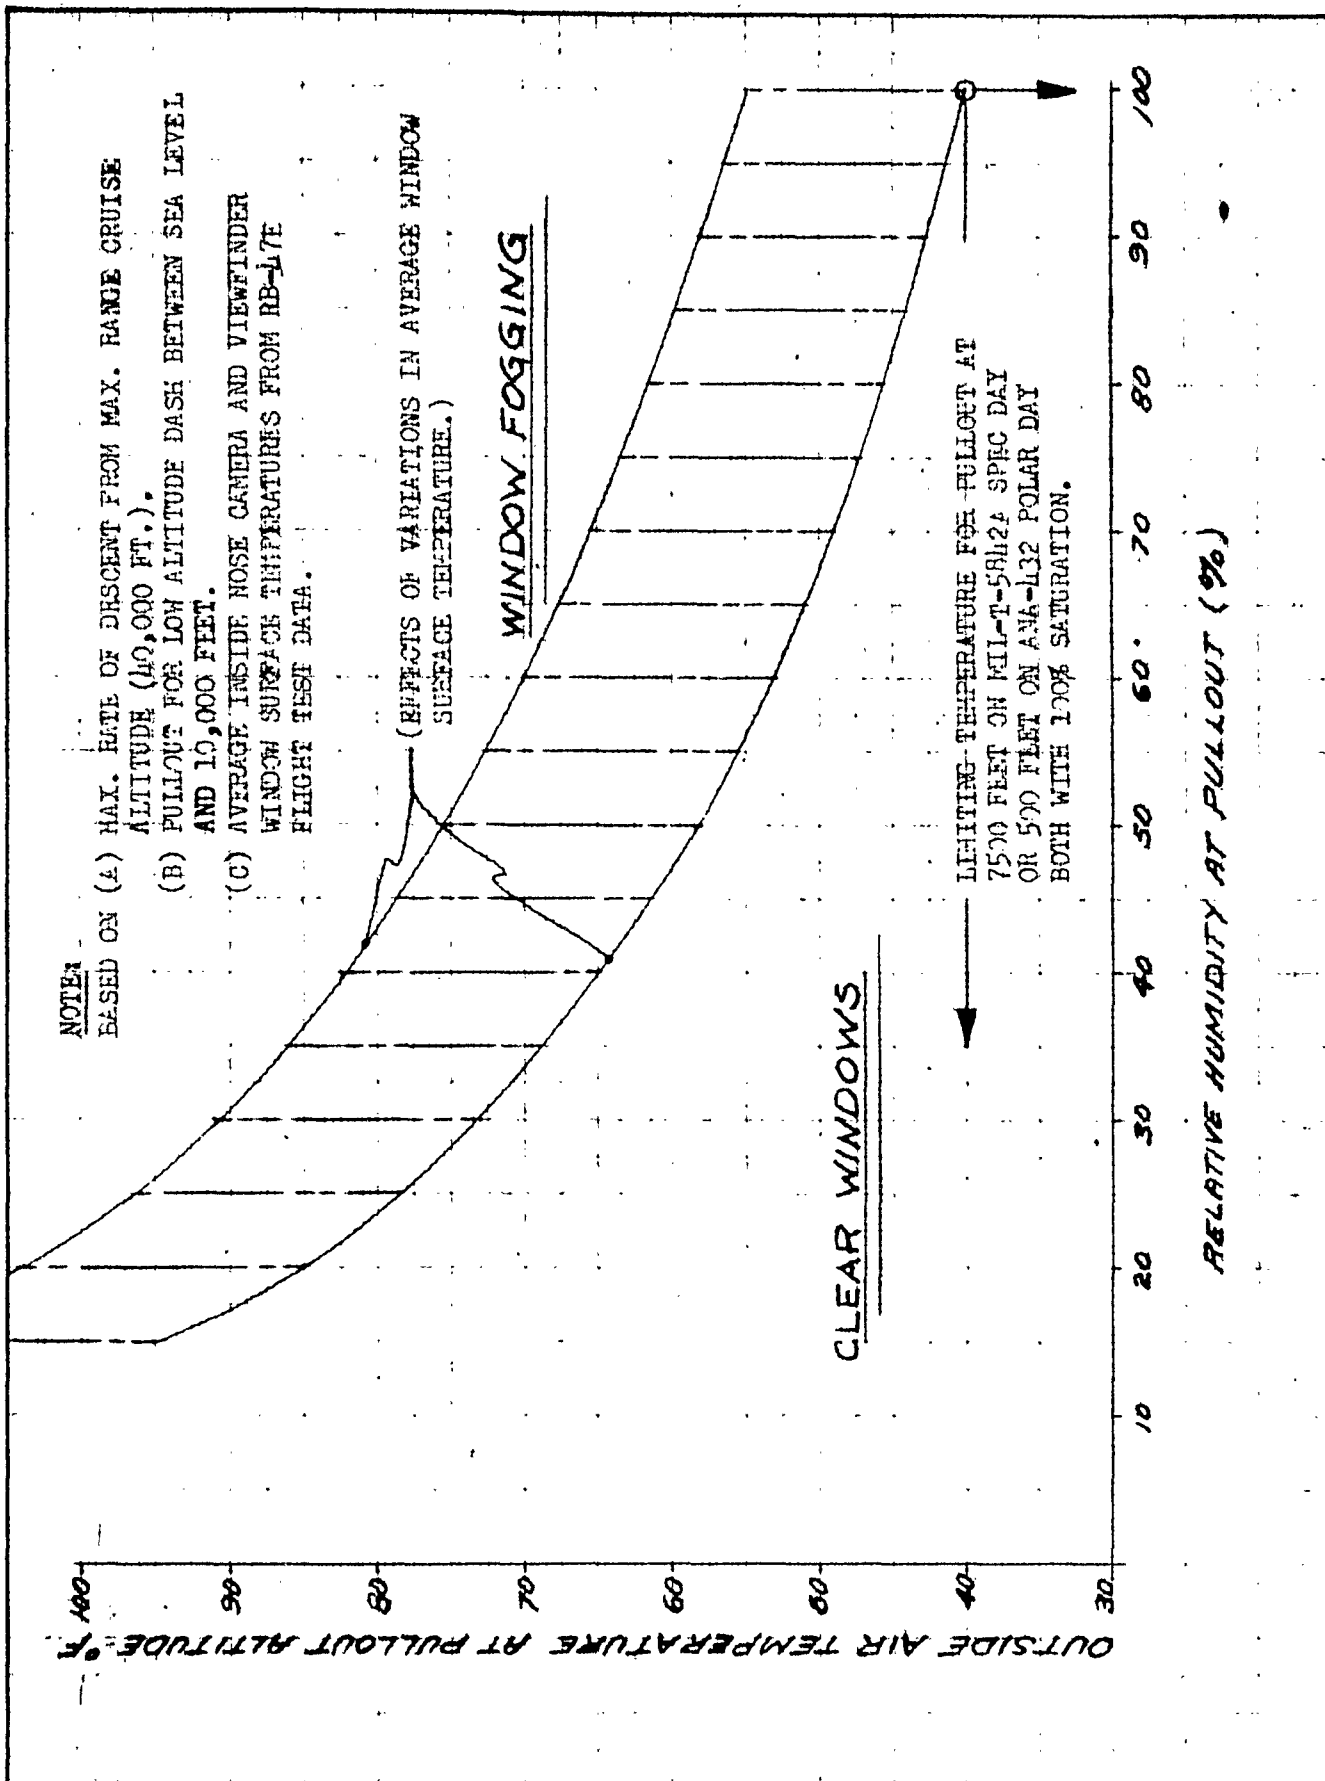
CALC	WAM	2/6/56	REVISED	DATE	PREDICTION OF CONDITIONS FOR FOG FREE RB-17E NOSE CAMERA WINDOWS AT DESCENT PULLOUT	Fig. 47A
CHECK						PR-17F
APR						VD-16013
APR						PAGE 91a OF
BOEING AIRPLANE COMPANY WICHITA 1, KANSAS						
CONTRACT NO.

Figure 40A is applicable to any atmospheric day conditions as long as the ambient sensible temperature (dry bulb) is below 100° F. The use

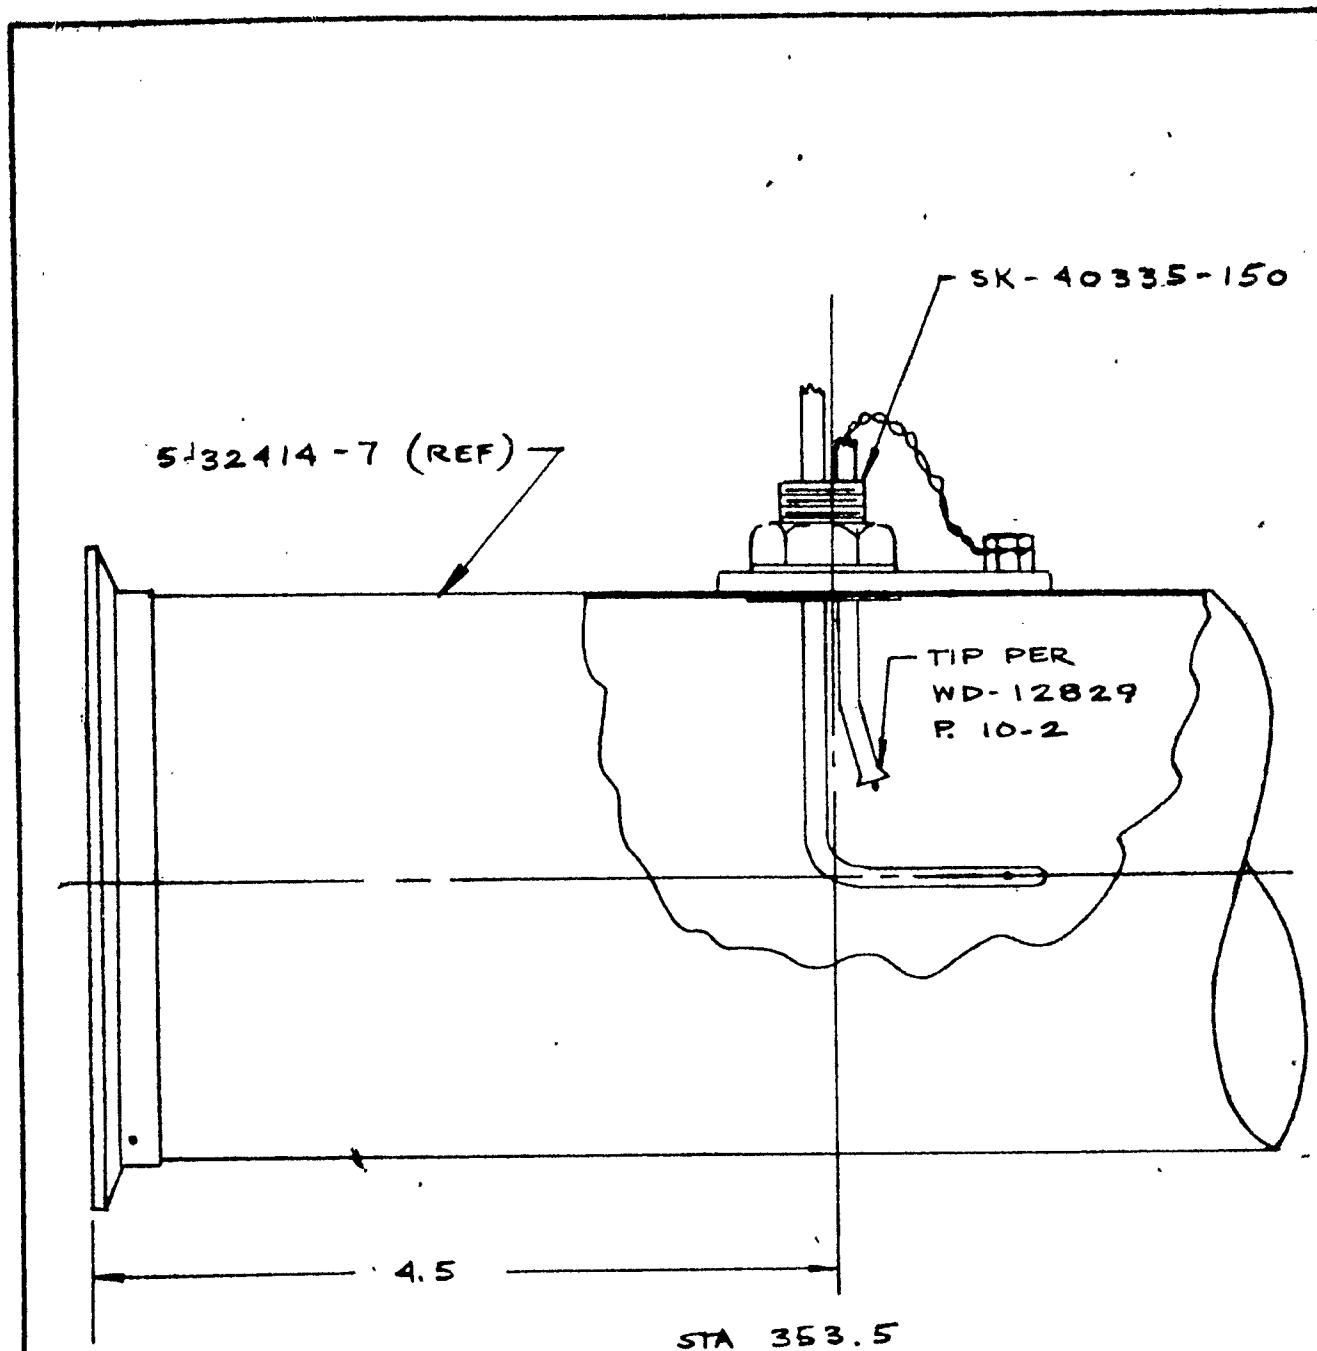
TC NO 46, STATIC NO 46  
ENGINE BLEED AIR SUPPLY

CALC	<i>[Signature]</i>	2-1-55	REVISED	DATE	FLIGHT TEST INSTRUMENTATION - ENGINE BLEED AIR SUPPLY STATION 353.5 BOEING AIRPLANE COMPANY WICHITA DIVISION WICHITA 1, KANSAS	FIGURE
CHECK	MPECHT	6-55				41
APR						RB-47E
APR						WD-14018
CONTRACT NO.						PAGE 92

The location of the temperature instrumentation on the window surfaces is shown in Figures 46, 49, 52 and 53. The well temperature thermocouple locations are shown in Figures 47, 48, 50 and 51. Duct line and miscellaneous pressure and temperature instrumentation locations are shown in Figures 41 to 45 inclusive. Additional details covering the remaining flight test instrumentation are included in Insert 1.

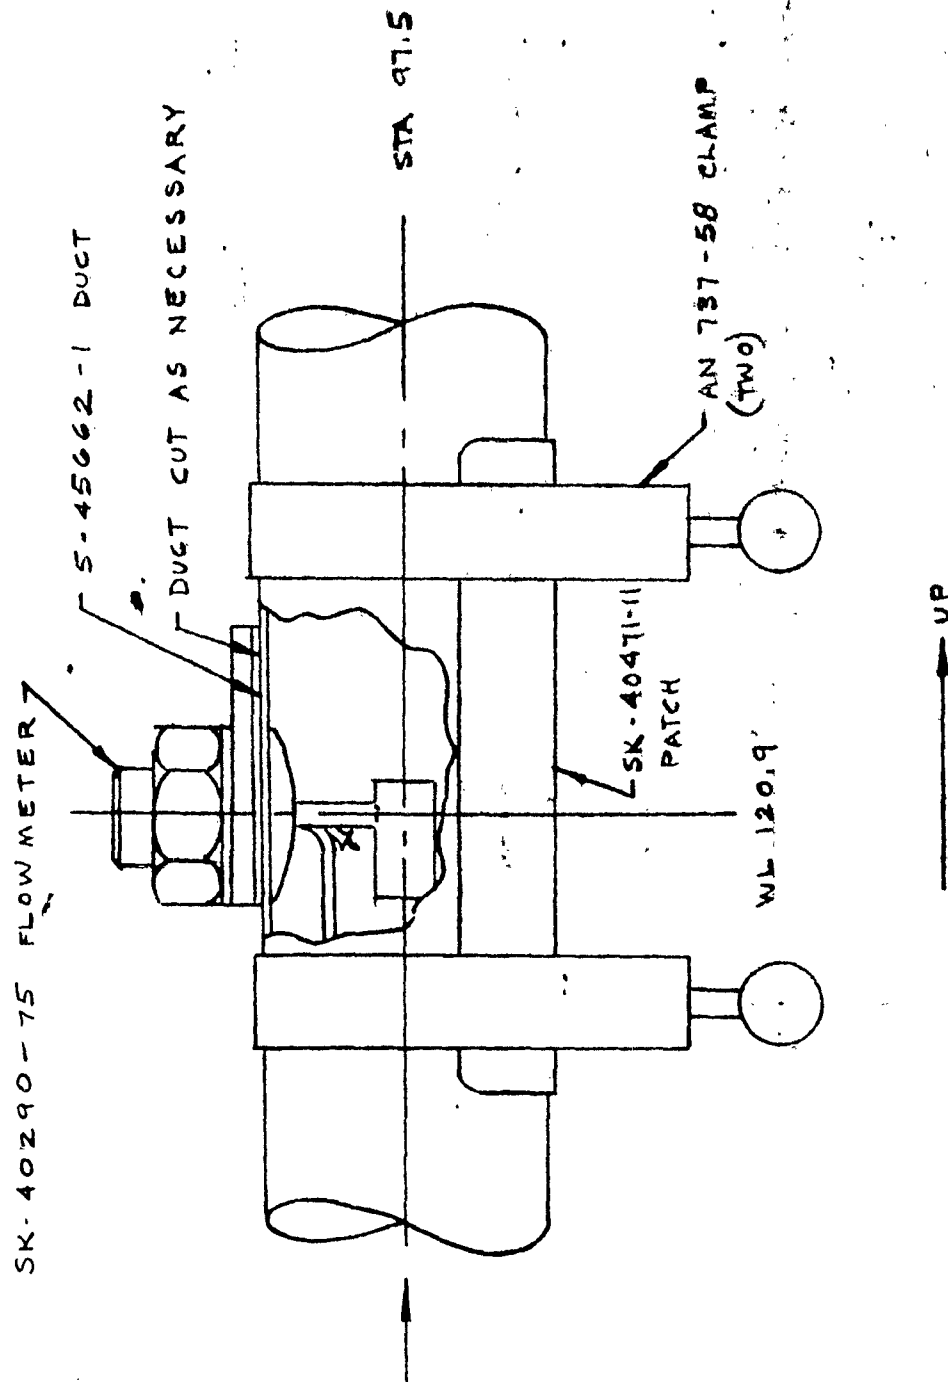
TC NO 47, STATIC NO. 47, TOTAL NO. 47  
ENGINE BLEED AIR SUPPLY

CALC	<i>9/12</i>	7-1-5	REVISED	DATE	FLIGHT TEST INSTRUMENTATION - ENGINE BLEED AIR SUPPLY STATION 97.5 W.L. 120.9 BOEING AIRPLANE COMPANY	FIGURE 42
CHECK	<i>N. PECHT</i>	6-55				WD-47E
APR					WD-14018	
APR					WICHITA DIVISION	WICHITA 1, KANSAS
CONTRACT NO.					PAGE 93

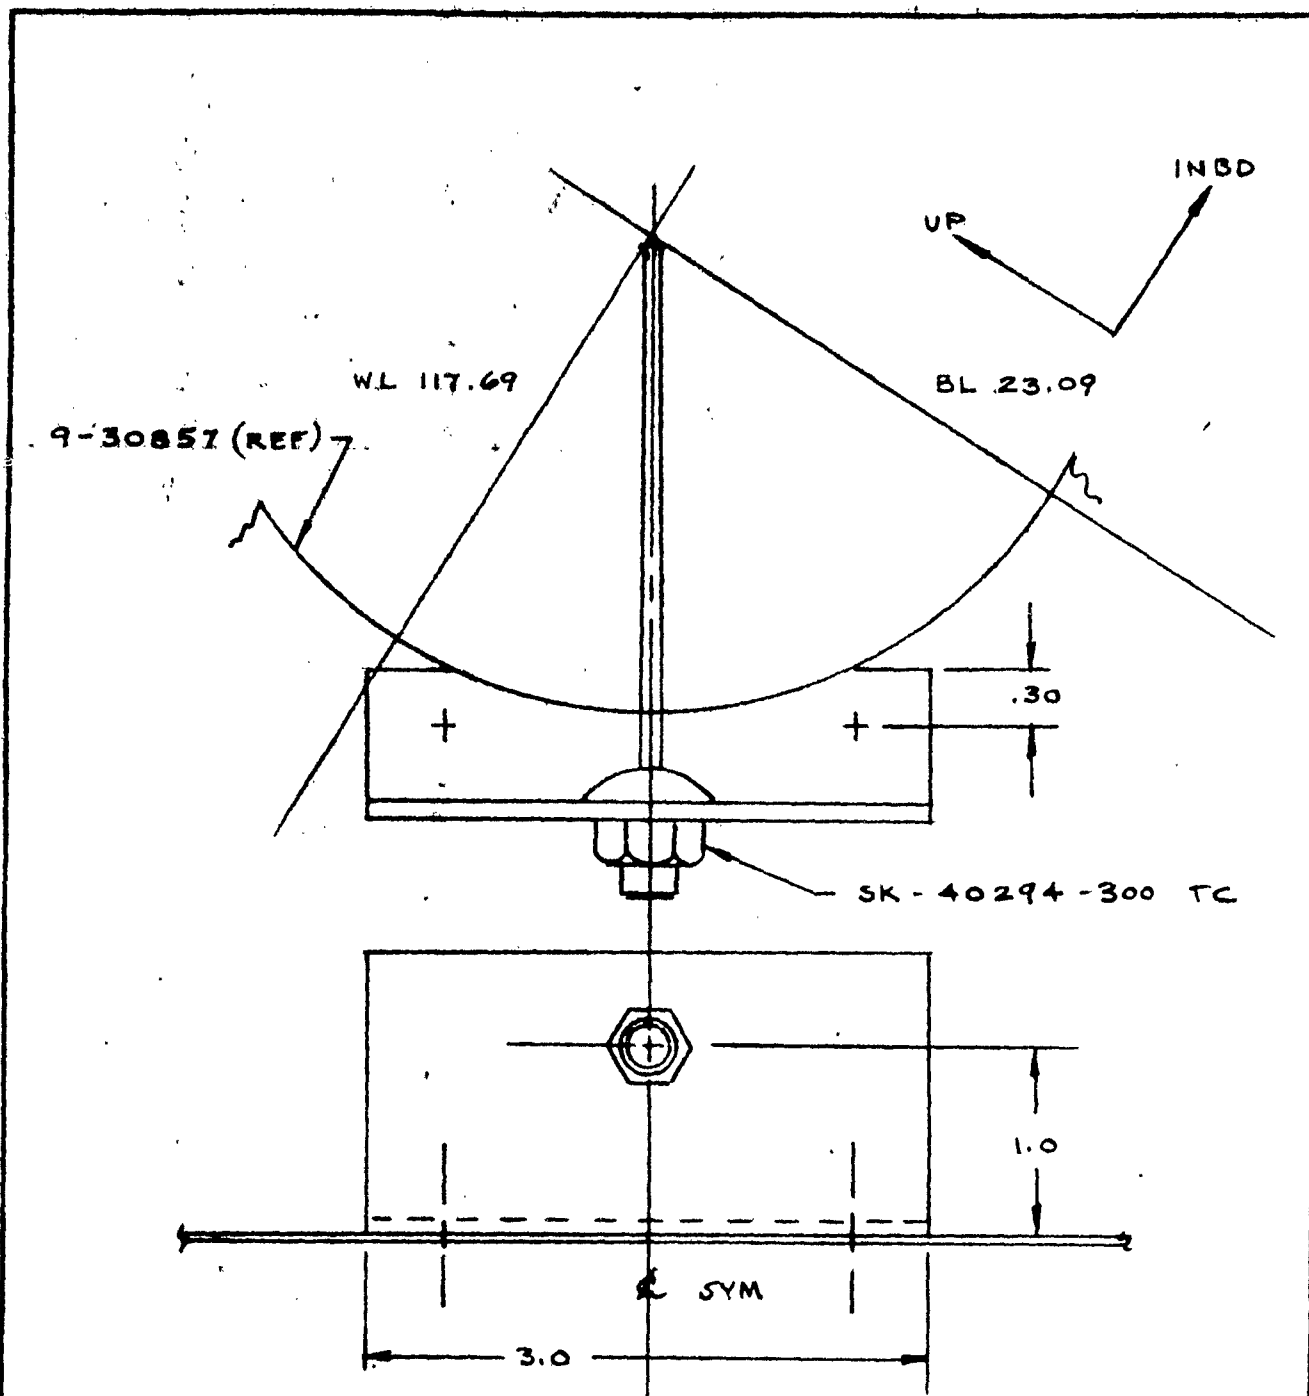
TC NO. 48

BLOWER INLET AIR

CALC	<i>ML</i>	7-1-7	REVISED	DATE	FLIGHT TEST INSTRUMENTATION - BLOWER INLET AIR STATION 78.5 W.L. 117.1 RBL 23.1  BOEING AIRPLANE COMPANY WICHITA DIVISION WICHITA 1, KANSAS	FIGURE 43
CHECK	M. PECHT	6-65				RB-47E
APR						WD-14018
APR						PAGE 94
CONTRACT NO.

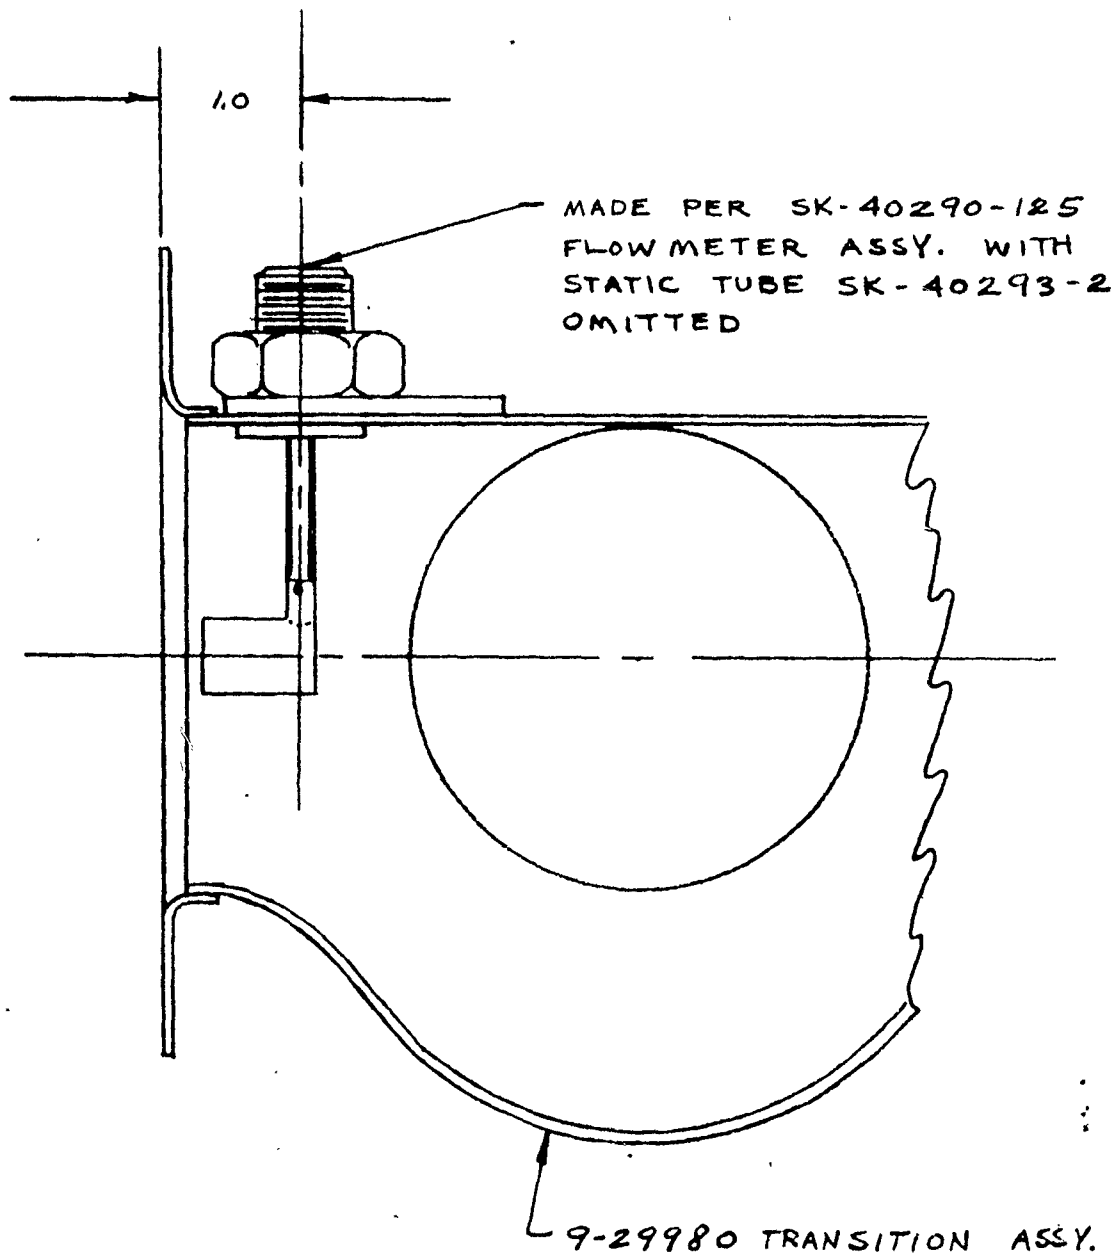
TC NO 51 , PITOT NO. 51  
BLOWER DISCHARGE AIR - UPSTREAM  
OF MIXING POINT.

CALC	7-6-4	REVISED	DATE	FLIGHT TEST INSTRUMENTATION - BLOWER DISCHARGE AIR - UPSTREAM OF MIXING POINT BOEING AIRPLANE COMPANY WICHITA DIVISION WICHITA 1, KANSAS	FIGURE 44
CHECK	M. PECHT 6-55				RD-47E
APP					ND-14018
APP					PAGE 95
CONTRACT NO.

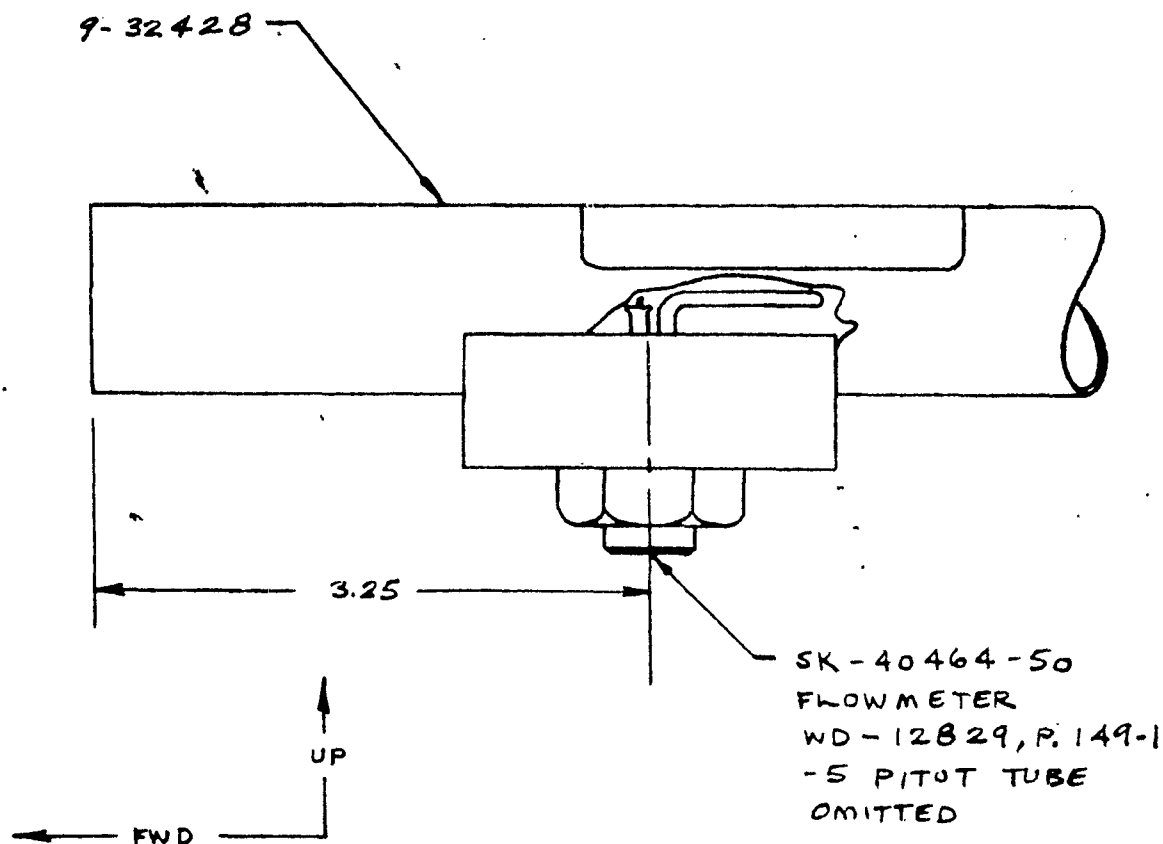
TC NO 59 , STATIC NO 59

NOSE CAMERA WINDOW OUTSIDE SUPPLY  
DUCT, DOWNSTREAM OF CHECK VALVE.

CALC	<i>MC</i> 7-6-8	REVISED	DATE	FLIGHT TEST INSTRUMENTATION - NOSE CAMERA WINDOW OUTSIDE SUPPLY DUCT, DOWNSTREAM OF CHECK VALVE	FIGURE 45
CHECK	M. PECHT 6-55				RB-47E
APR					WD-14018
APR					PAGE 96
CONTRACT NO.				BOEING AIRPLANE COMPANY WICHITA DIVISION WICHITA 1, KANSAS

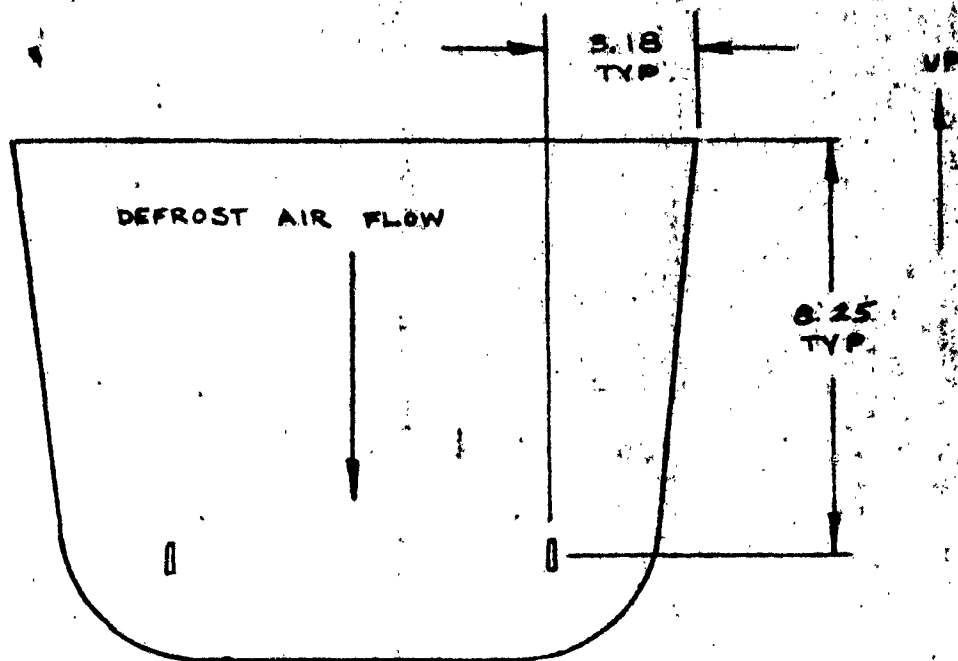
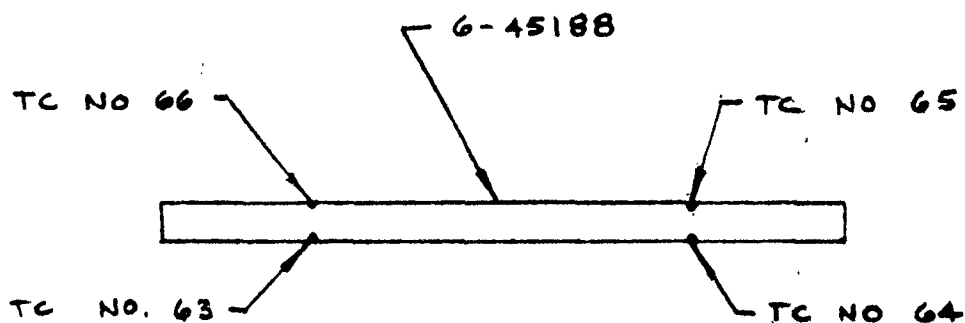
TC'S NO. 63, 64, 65, + 66  
SURFACE TEMPERATURE, NOSE  
CAMERA WINDOW

CALC	<i>7-6-7</i>	REVISED	DATE	FLIGHT TEST INSTRUMENTATION - SURFACE TEMPERATURE, NOSE CAMERA WINDOW	FIGURE 46
CHECK	<i>M. PECHT</i>	6-55			RE-47E
APR				BOEING AIRPLANE COMPANY WICHITA DIVISION WICHITA 1, KANSAS	WD-14018
APR					PAGE 97
CONTRACT NO.

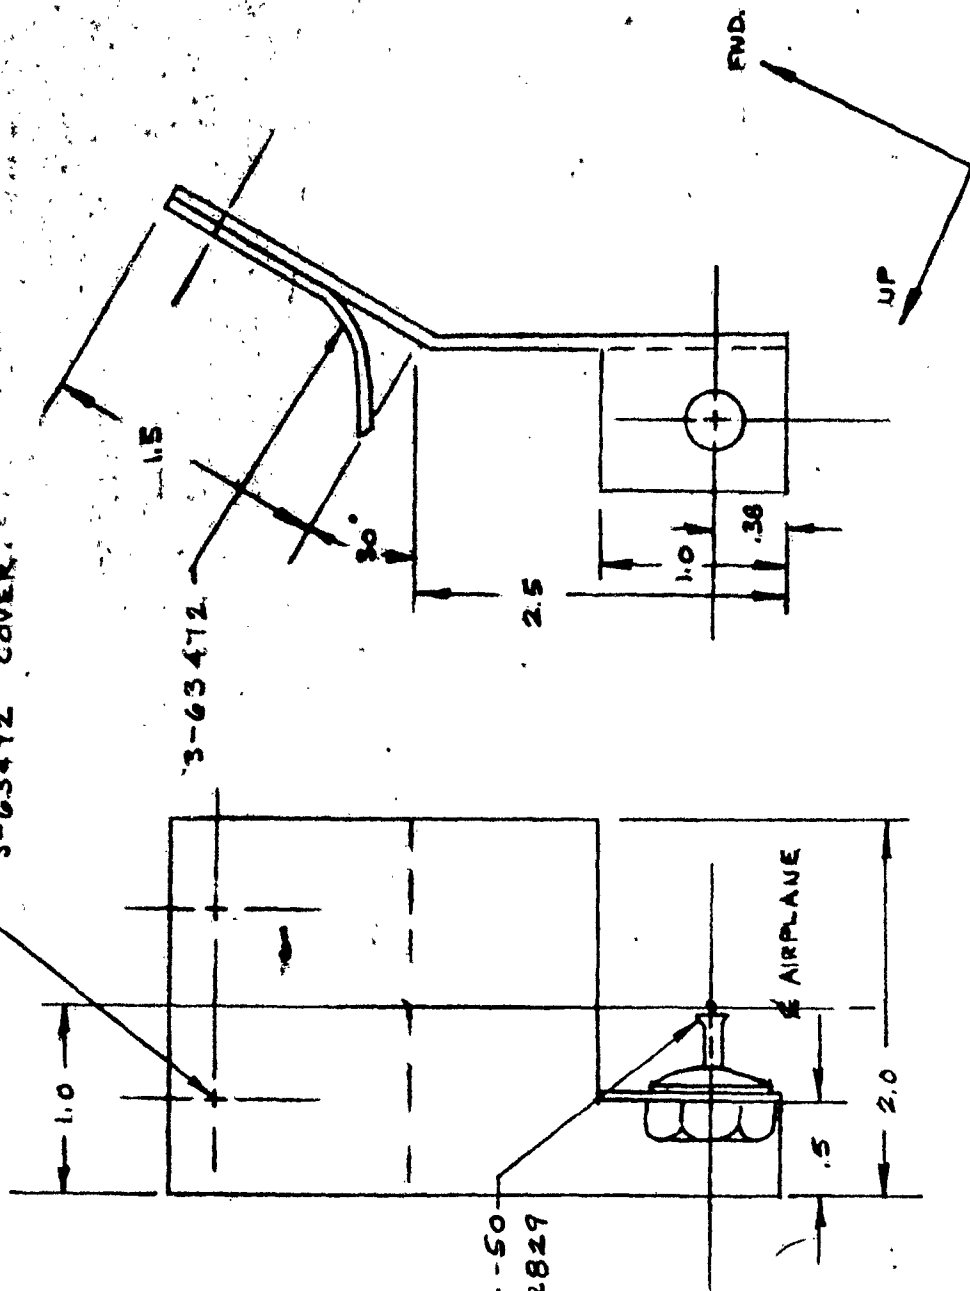
SK-40294-50  
TC, WD-12829  
P. 30-1

TC NO 67

CALC	CHKD	APR	APR	REVISED	DATE	FLIGHT TEST INSTRUMENTATION - WELL TEMPERATURE, NOSE CAMERA WINDOW	FIGURE 47
CHKD	APR	APR					RB-47E WD-14018
CONTRACT NO.						BOEING AIRPLANE COMPANY WICHITA DIVISION	WICHITA 1, KANSAS PAGE 98

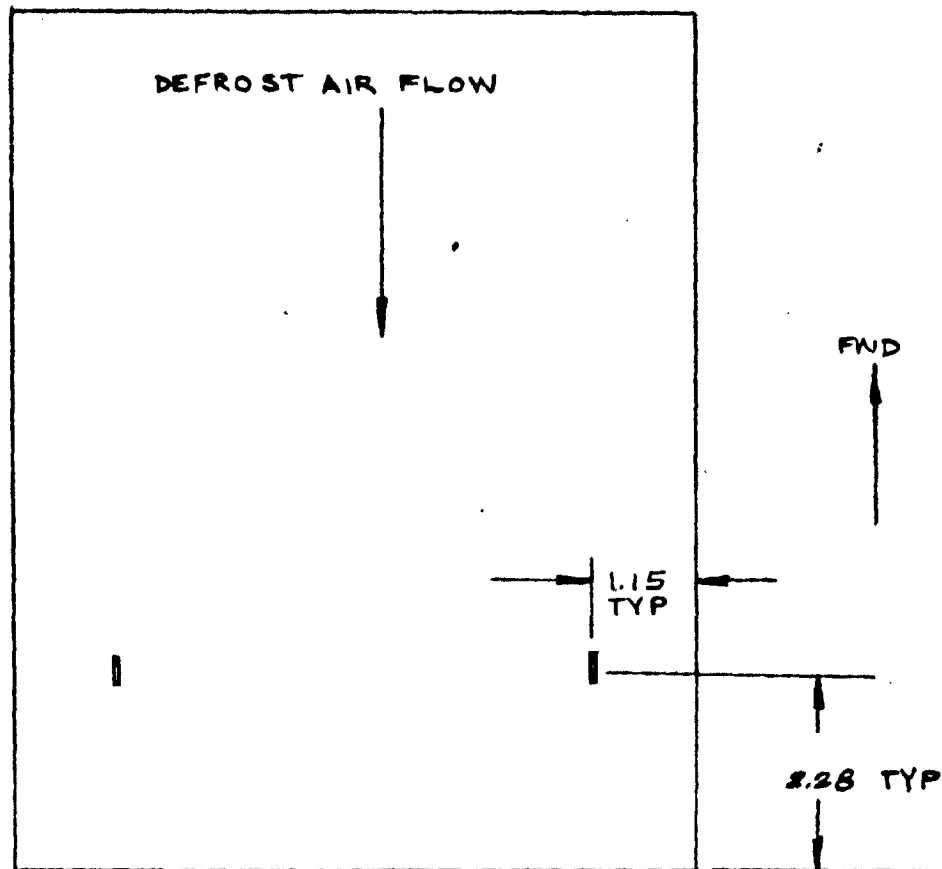
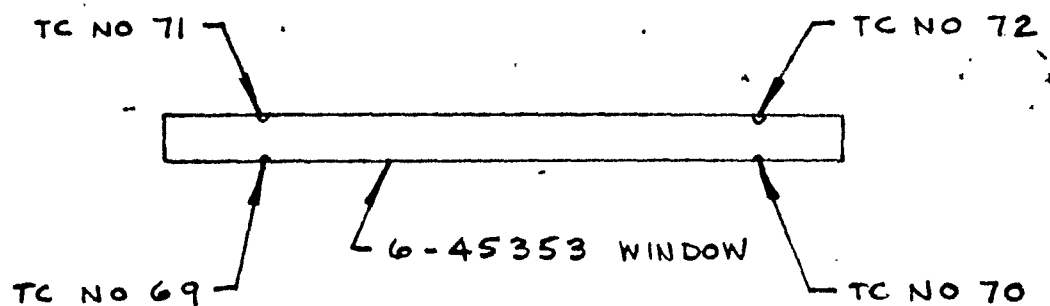
TC'S NO 69, 70, 71, + 72

SURFACE TEMPERATURE - VIEWFINDER WINDOW

CALC	ALL 7-7-4	REVISED	DATE	CHECK	M. PRCHT 6-55			APR				APR				<p>FLIGHT TEST INSTRUMENTATION - SURFACE TEMPERATURE, VIEWFINDER WINDOW</p> <p>BOEING AIRPLANE COMPANY</p> <p>WICHITA DIVISION WICHITA 1, KANSAS</p>	<p>FIGURE 49</p> <p>RB-47E</p> <p>WD-14018</p> <p>PAGE 100</p>
CALC	ALL 7-7-4	REVISED	DATE															
CHECK	M. PRCHT 6-55																	
APR																		
APR																		
<p>CONTRACT NO.</p>
